2016 Annual Site Inspection and Monitoring Report for Uranium Mill Tailings Radiation Control Act Title II Disposal Sites

November 2016

**U.S. Department of Energy
Office of Legacy Management**

**2016 Annual Site Inspection and Monitoring Report
for
Uranium Mill Tailings Radiation Control Act
Title II Disposal Sites**

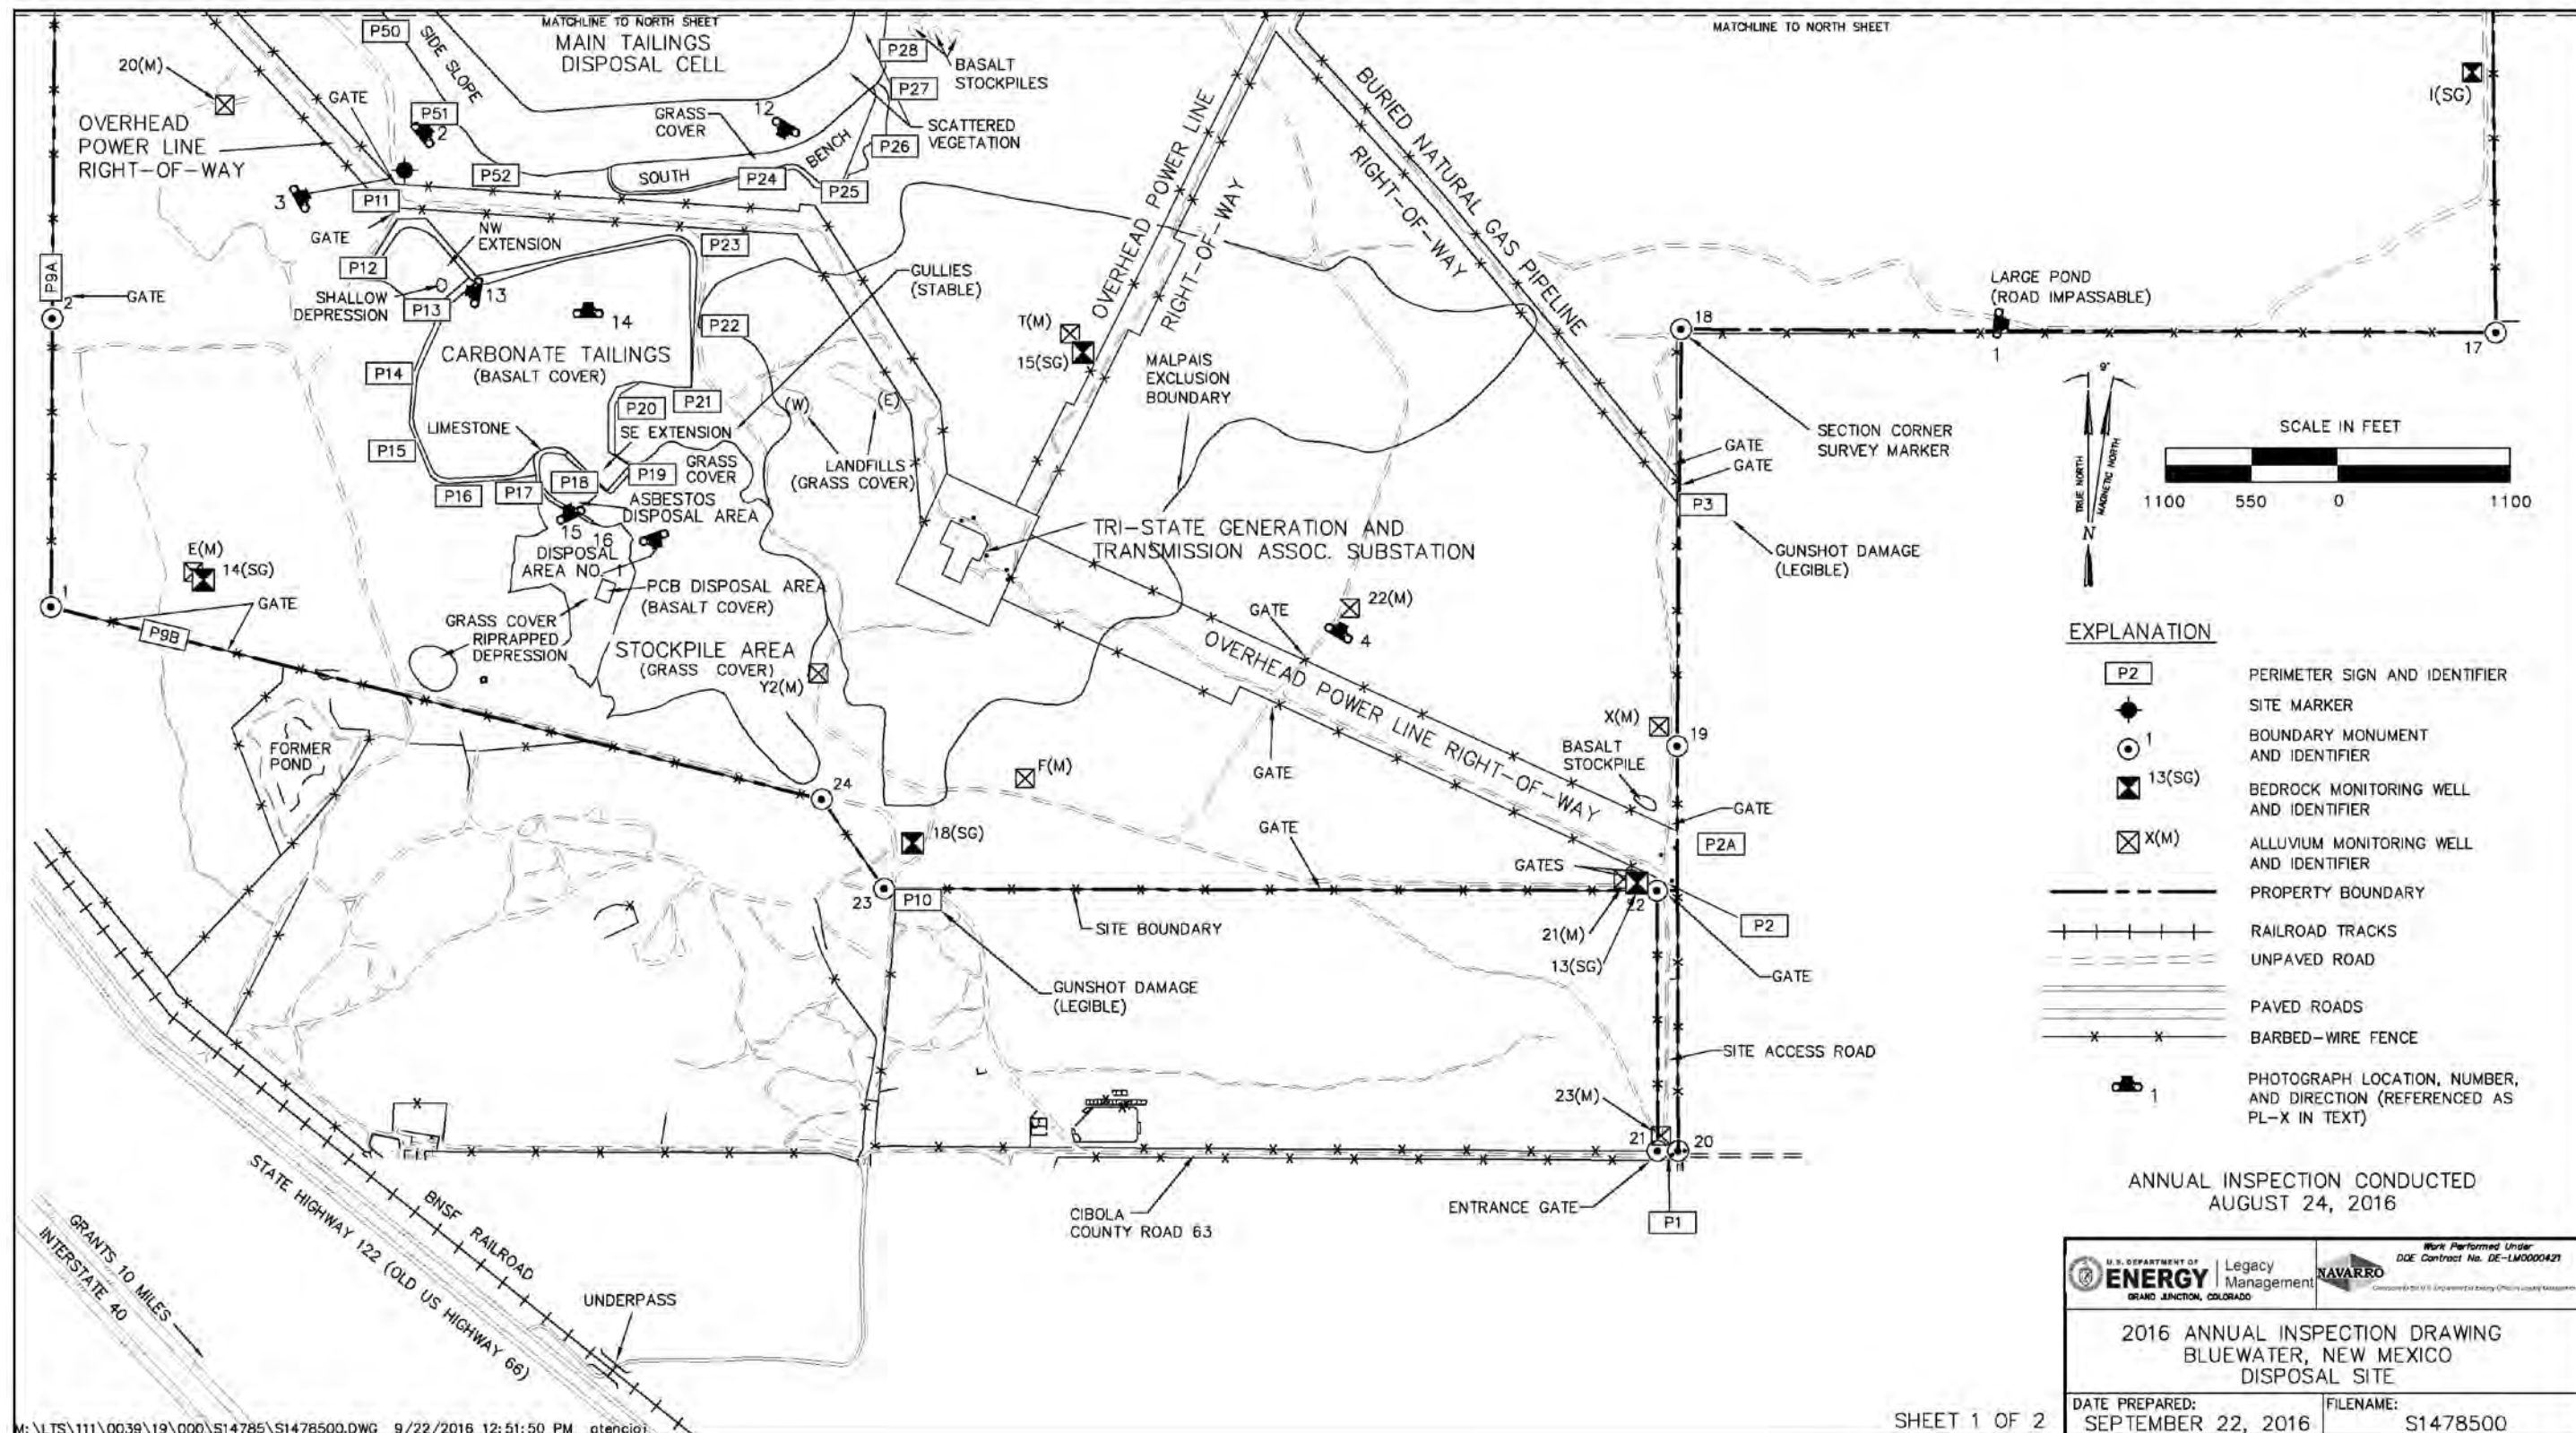
Figure 1-1. 2016 Annual Inspection Drawing for the Bluewater, New Mexico, Disposal Site (South Area)

Figure 1-1 and Figure 1-2 show the locations of the site surveillance features. Inspection results and recommended maintenance activities associated with site surveillance features are included in the following subsections. Photographs to support specific observations are identified in the text and on the figures by photograph location (PL) numbers.

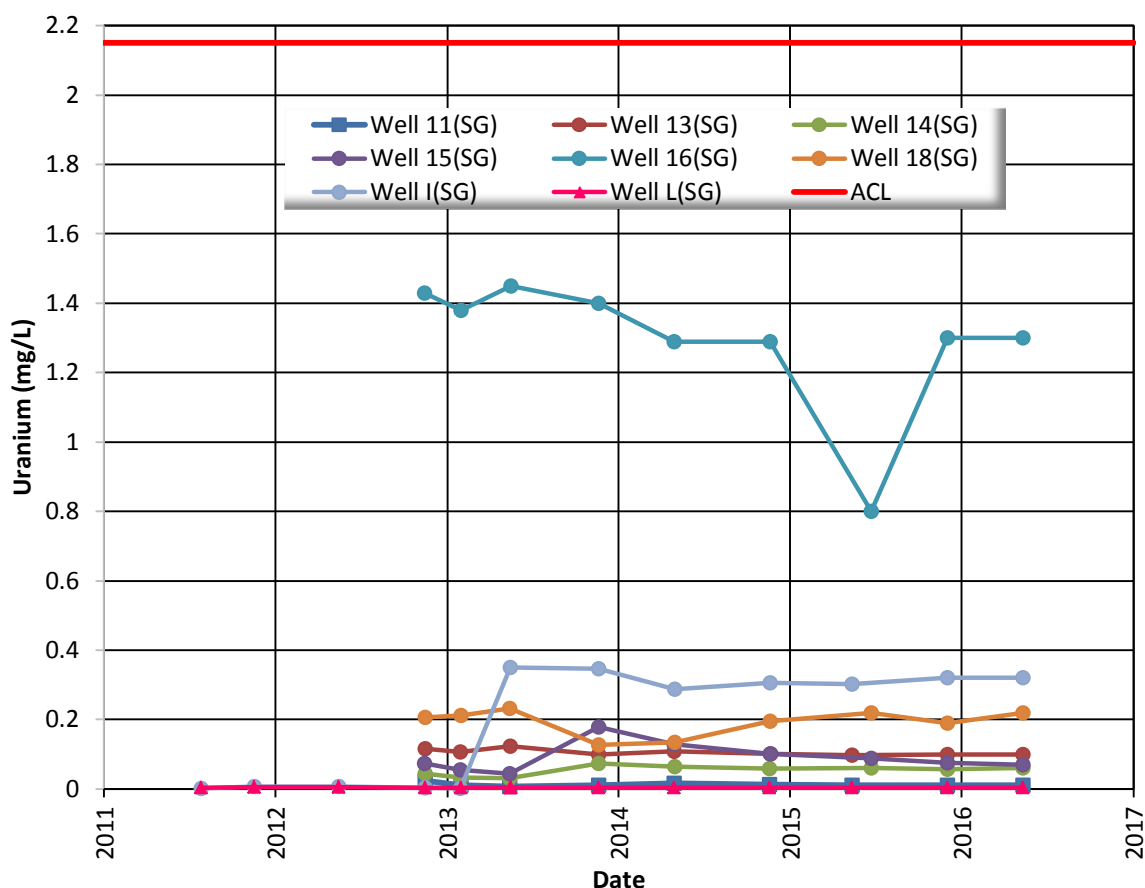
Figure 1-4. Uranium Concentrations in the San Andres Aquifer at the Bluewater, New Mexico, Disposal Site

Uranium concentrations in the San Andres aquifer are shown on Figure 1-4. Uranium concentrations in well I(SG) before 2013 were erroneously low because of an incorrect sampling depth in the well. Uranium concentrations at POC wells OBS-3 and S(SG) are not shown in Figure 1-4 because the well screens are encrusted with iron scale that has resulted in erroneously low uranium concentrations.

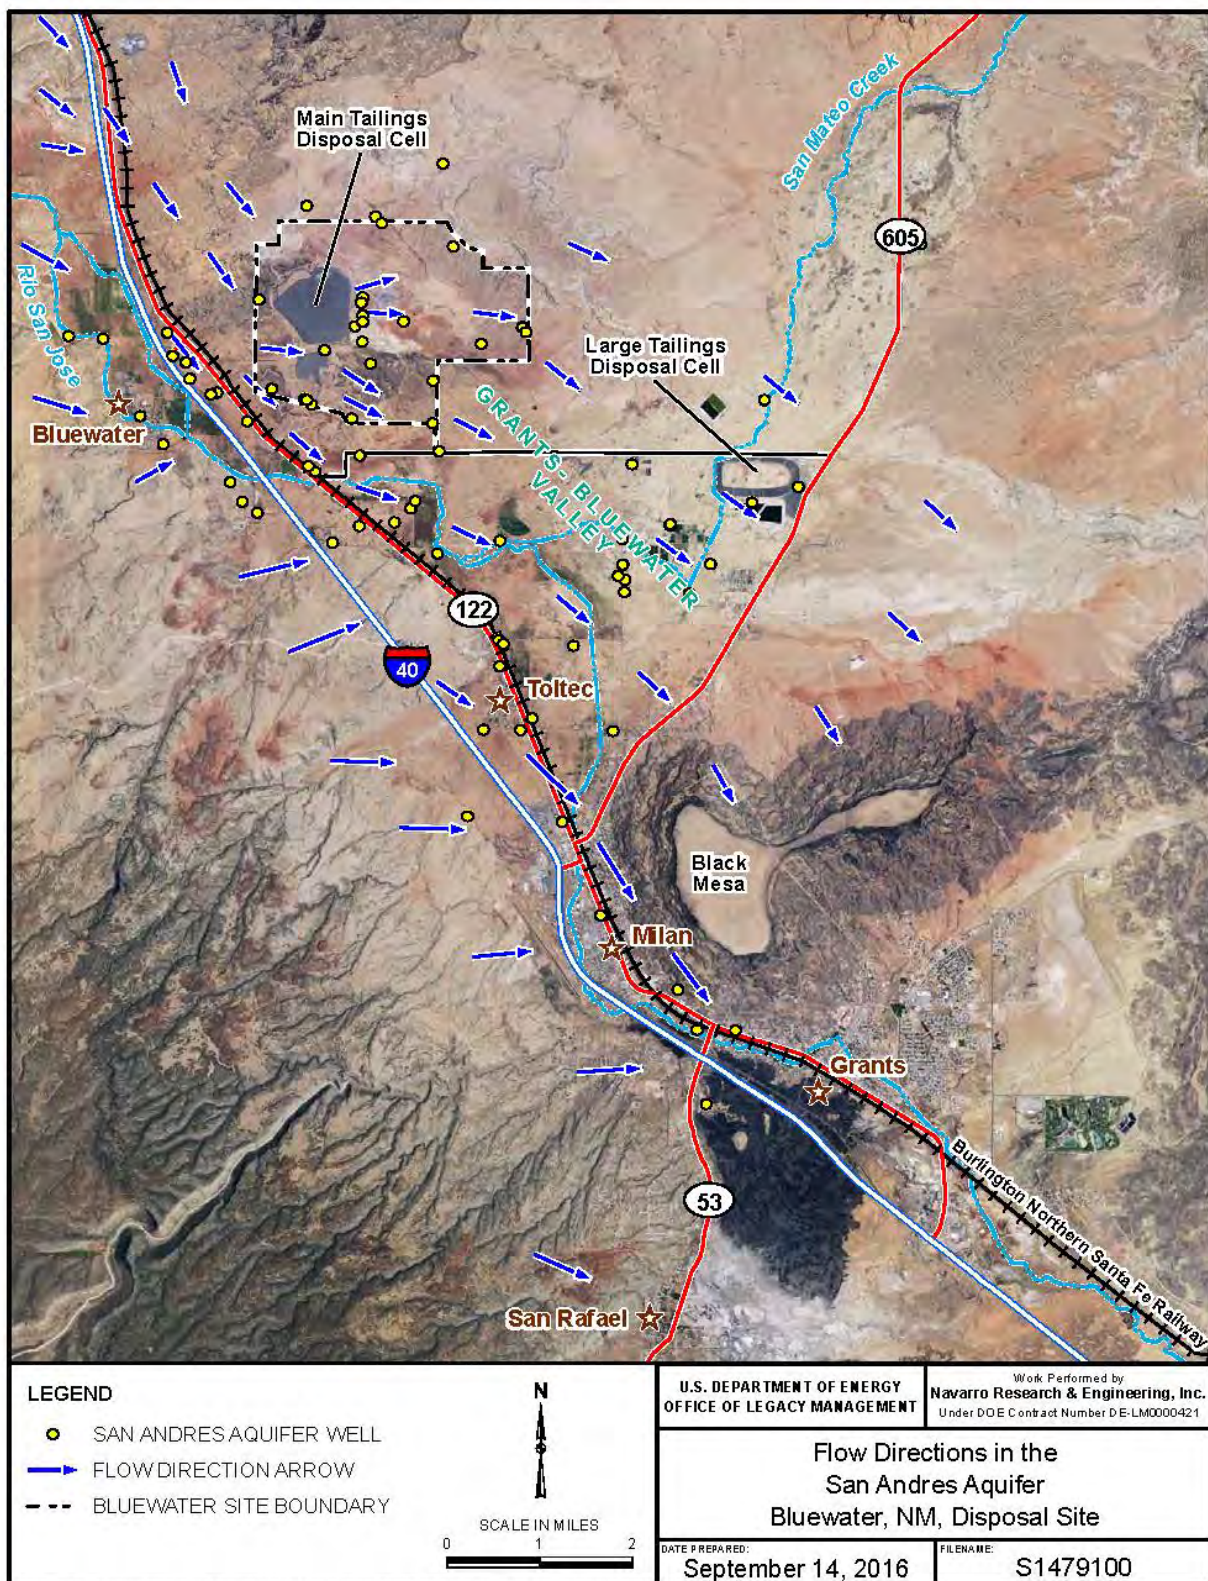
Figure 1-5. Groundwater Flow Directions in the San Andres Aquifer at the Bluewater, New Mexico, Disposal Site

The extent of uranium contamination in the San Andres aquifer and the potential risk to downgradient groundwater users was evaluated in DOE's groundwater conceptual model. Evaluation of previous groundwater studies in the region and available groundwater data indicated that the flow path of the aquifer from the Bluewater site is in the east-southeast direction. The groundwater from the site passes under the Homestake mill site and continues through an area north of the community of Grants. The flow path from the Bluewater site is substantially north of the Milan and Grants municipal wells (Figure 1-5).

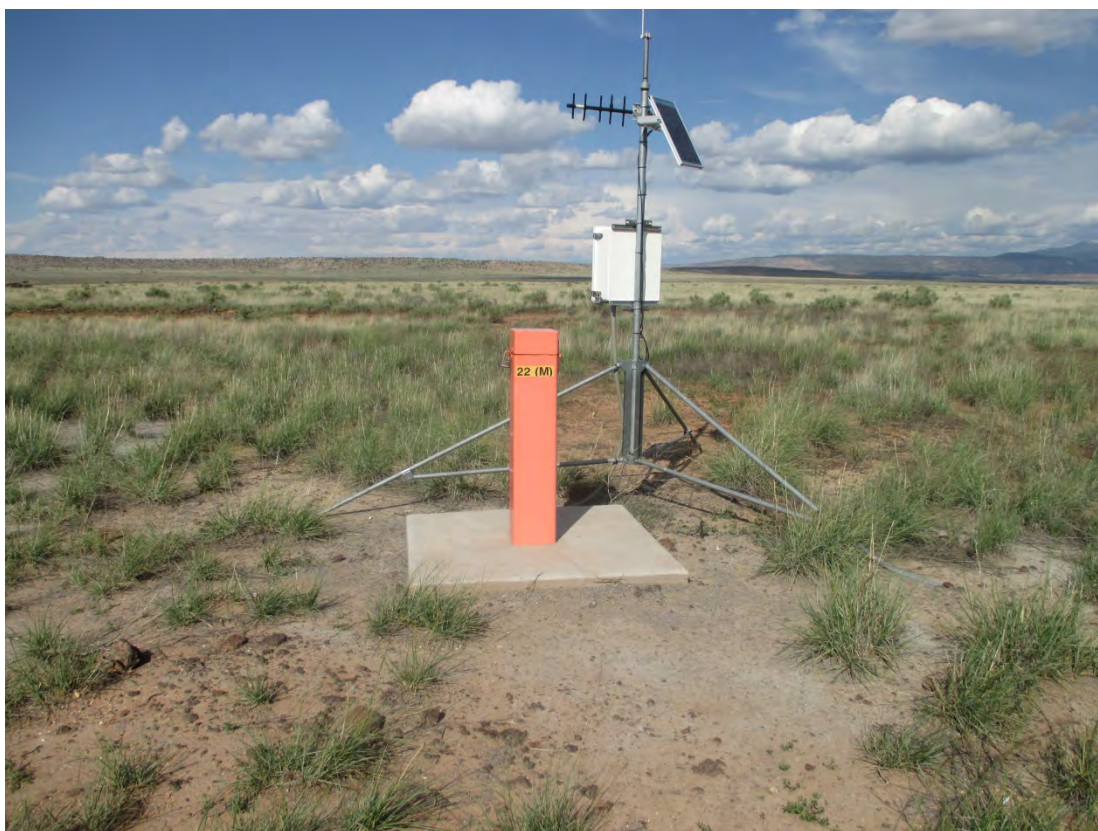
PL-4. Monitoring Well 22(M)

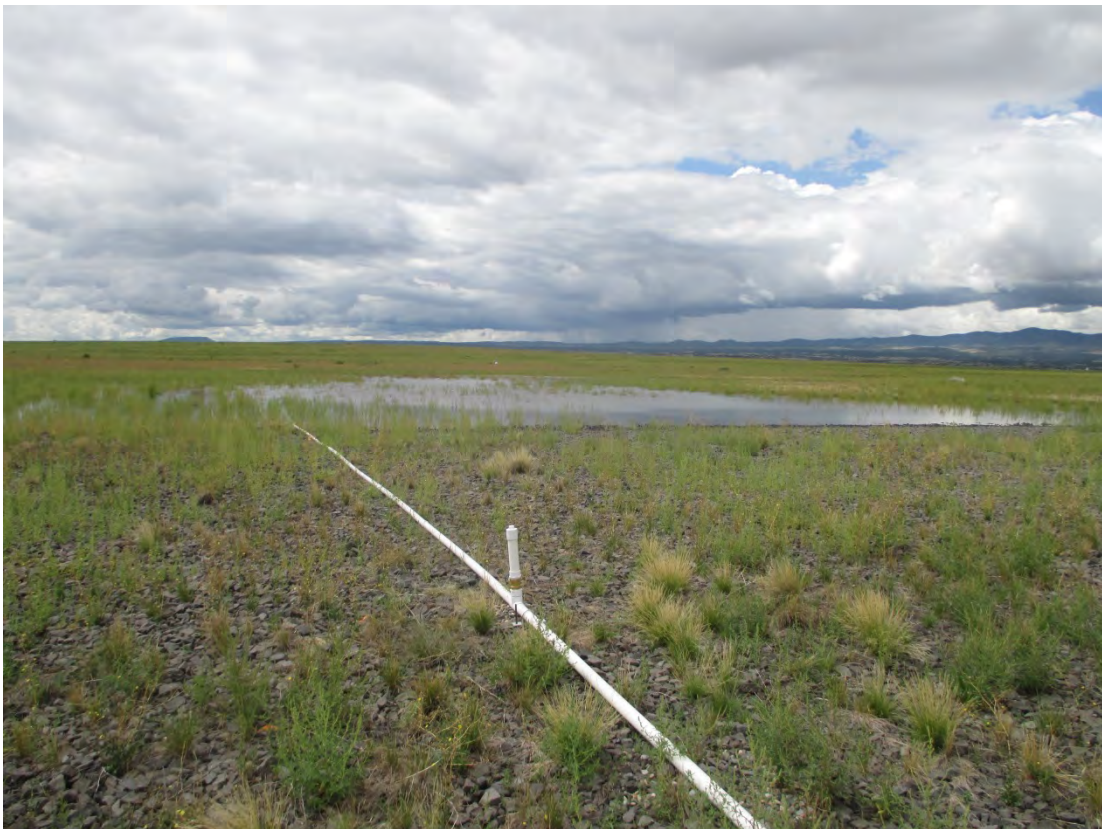
PL-10. Pond Dewatering Siphon on Main Tailings Disposal Cell

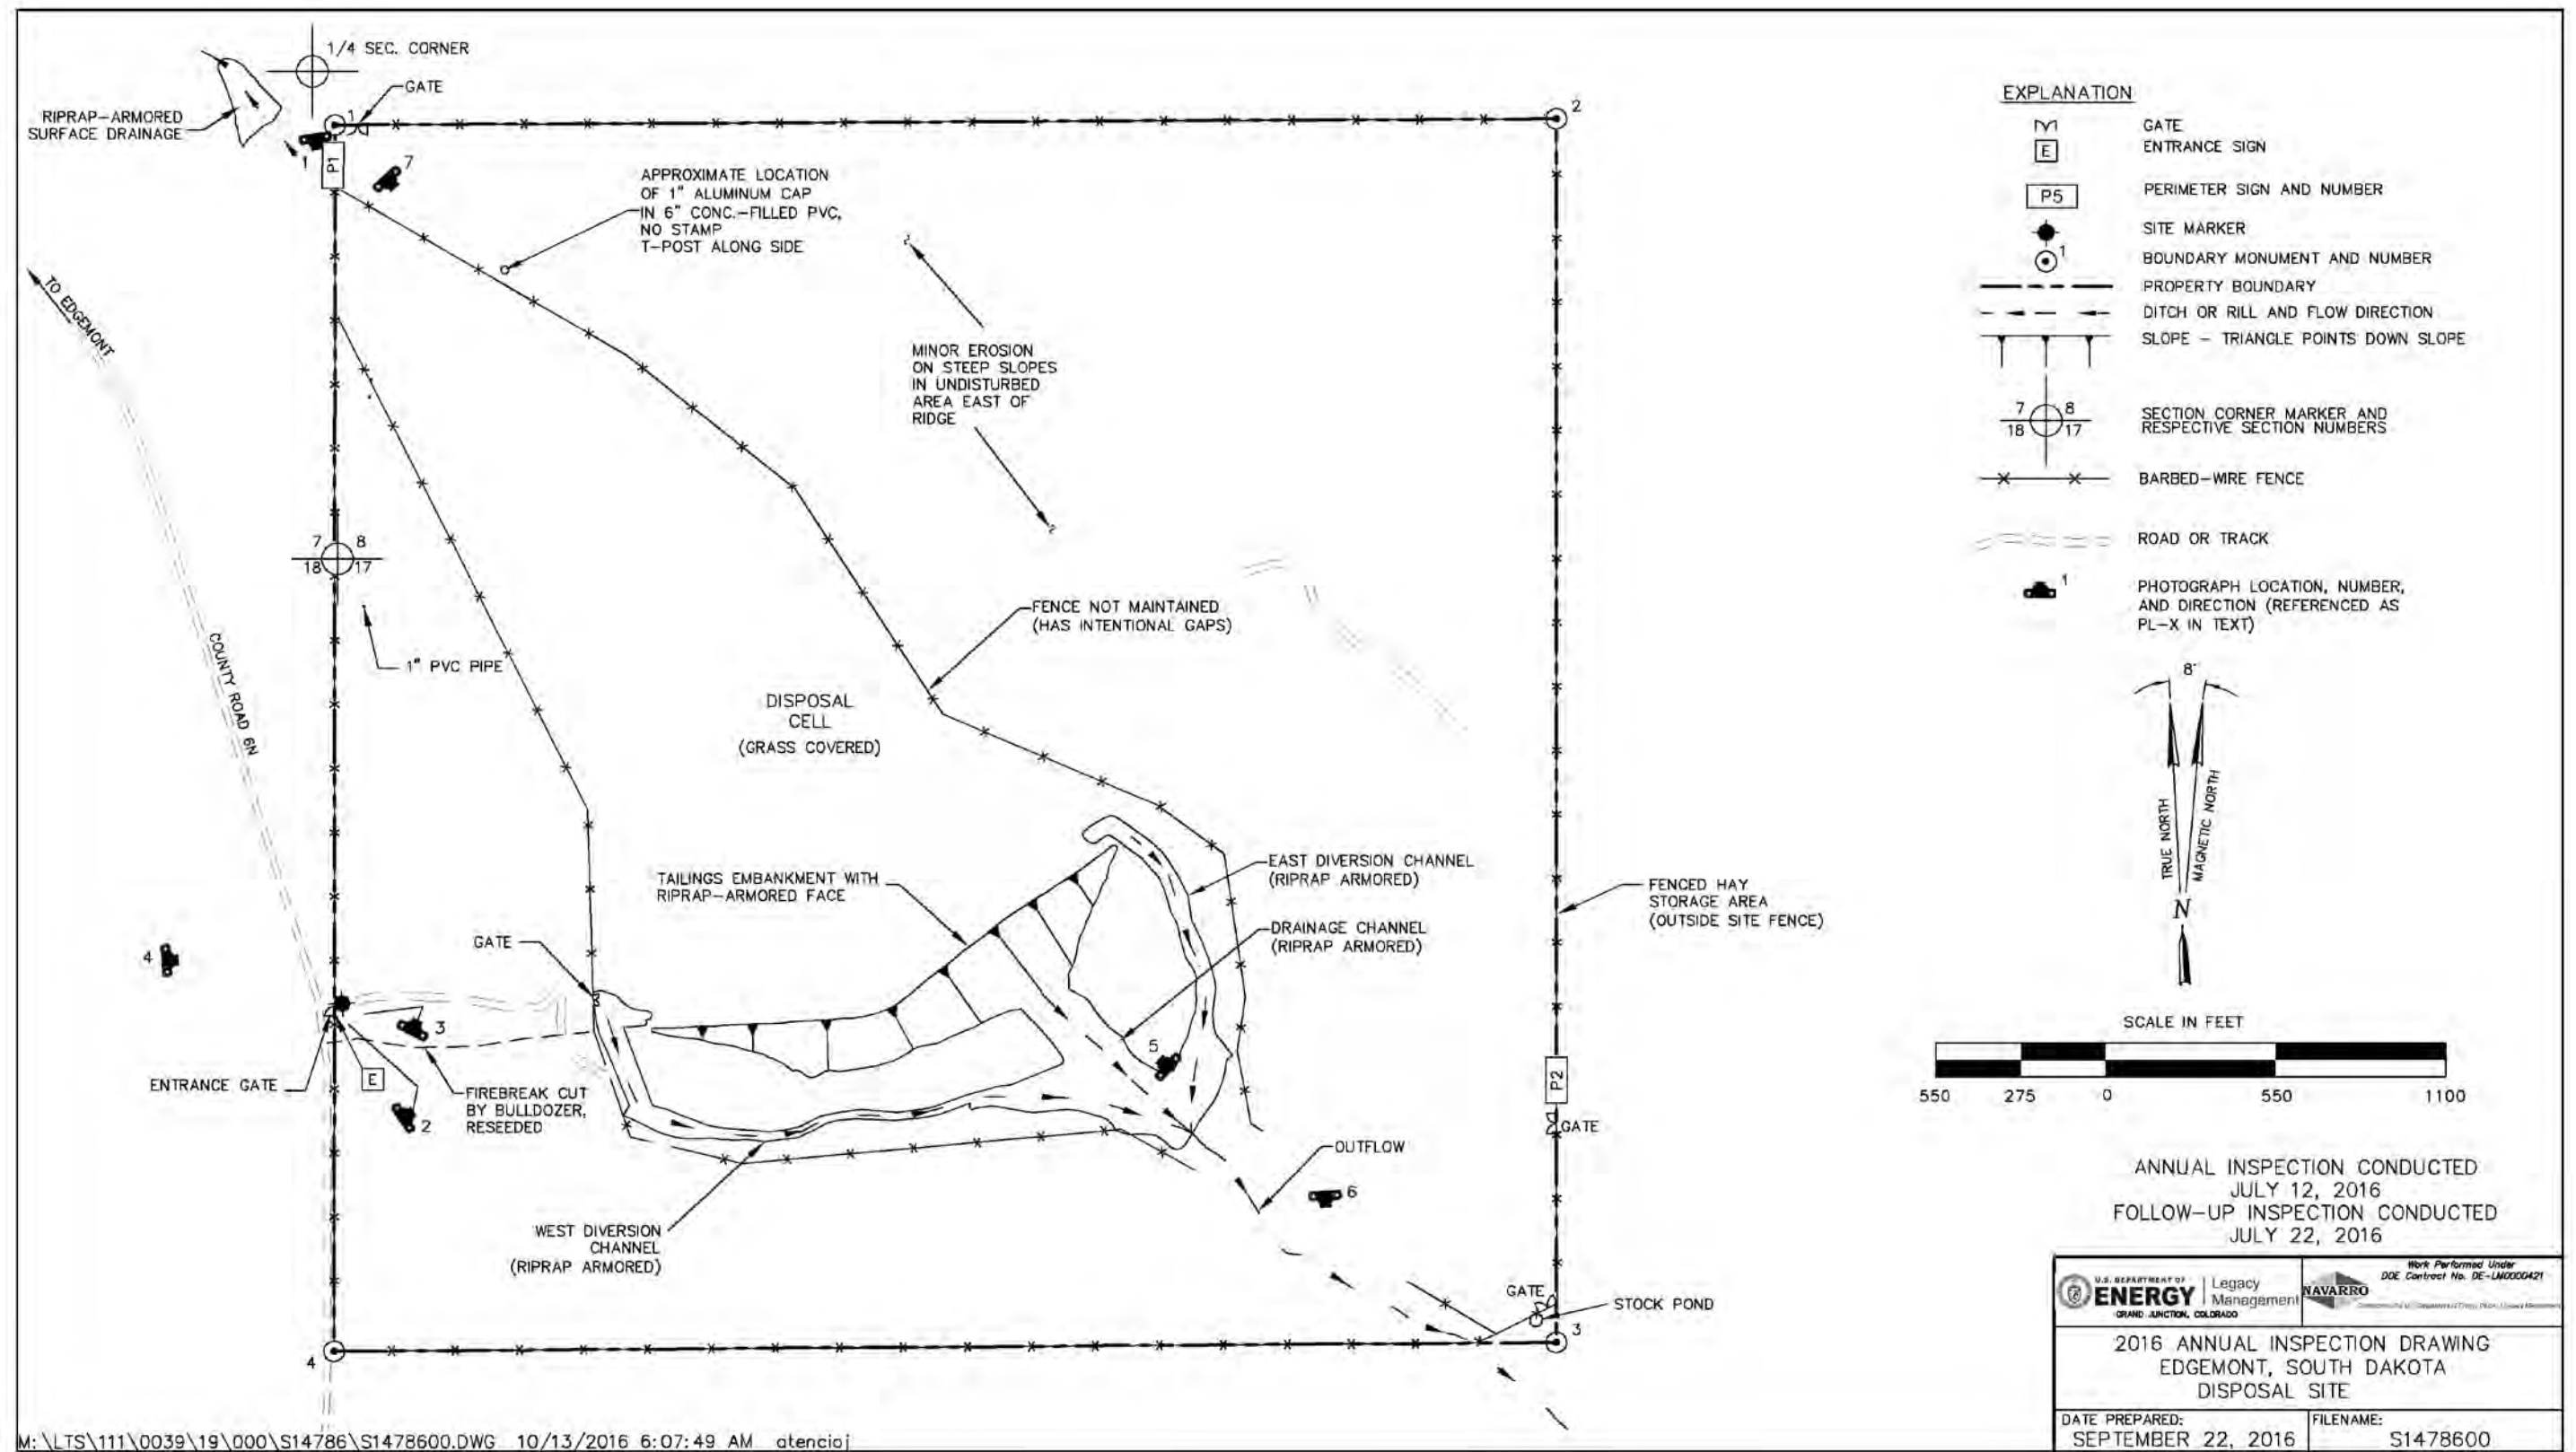
Figure 2-1. 2016 Annual Inspection Drawing for the Edgemont, South Dakota, Disposal Site

Figure 2-1 shows the locations of site surveillance features. Inspection results and recommended maintenance activities associated with site surveillance features are included in the following subsections. Photographs to support specific observations are identified in the text and on Figure 2-1 by photograph location (PL) numbers.

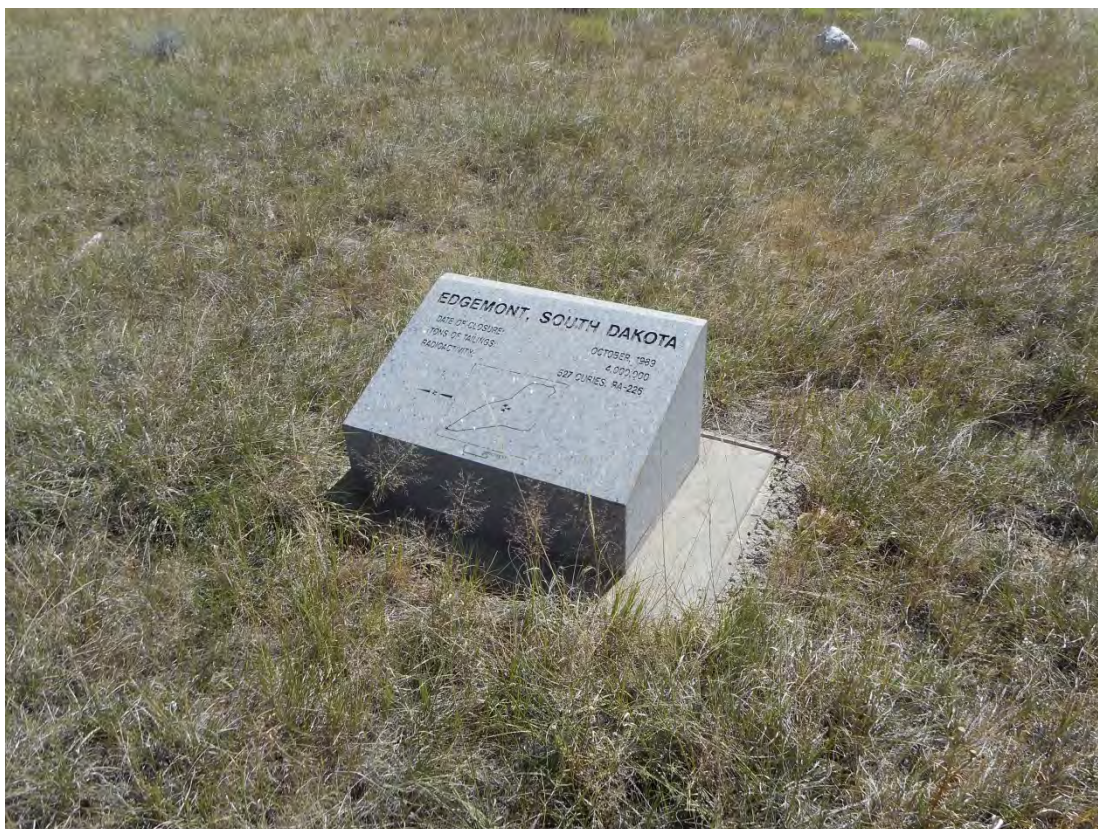
PL-2. Granite Site Marker July 12, 2016

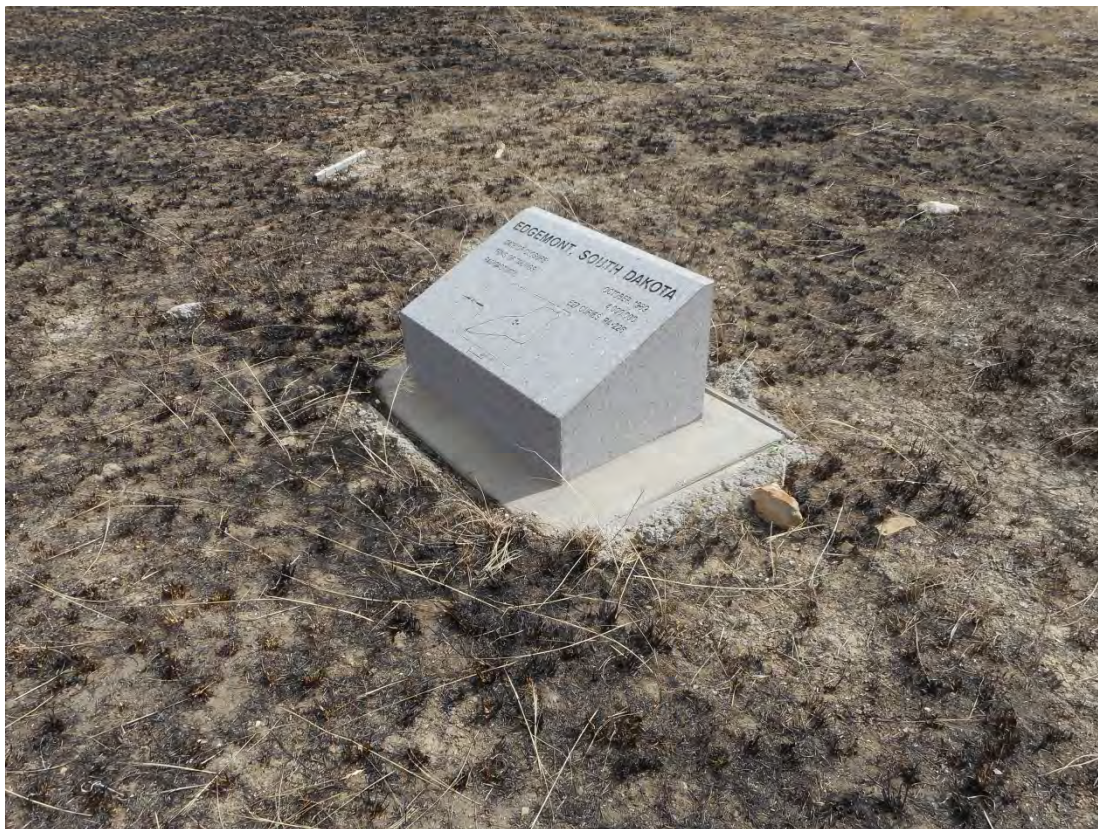
PL-3. Granite Site Marker July 22, 2016

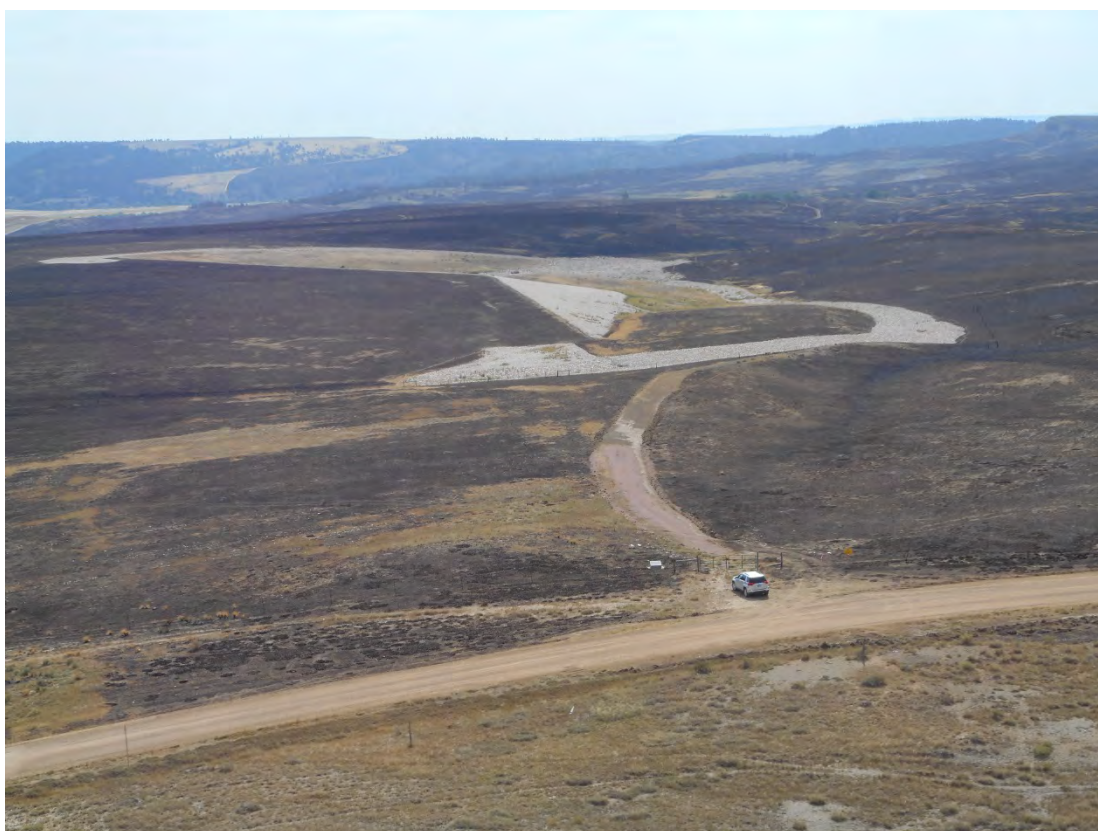
The steel wire perimeter fence was not damaged except for a short section near the entrance gate, which was repaired by the grazing licensee. The perimeter signs mounted on the fence were undamaged. The only fire-related damage requiring repair was caused by construction of the firebreak. The firebreak is approximately 20 feet wide and extends from the entrance gate to the inner fence near the west drainage channel, but it does not go east of the inner fence, as noted on Figure 2-1. This section was reseeded and regraded by the licensee. The entrance signpost was knocked over and will be reset by the licensee, with a new sign installed. All engineered structures, such as the embankment and diversion channels, were undamaged.

PL-4. Tailings Embankment and Diversion Channels, Looking East, July 22, 2016

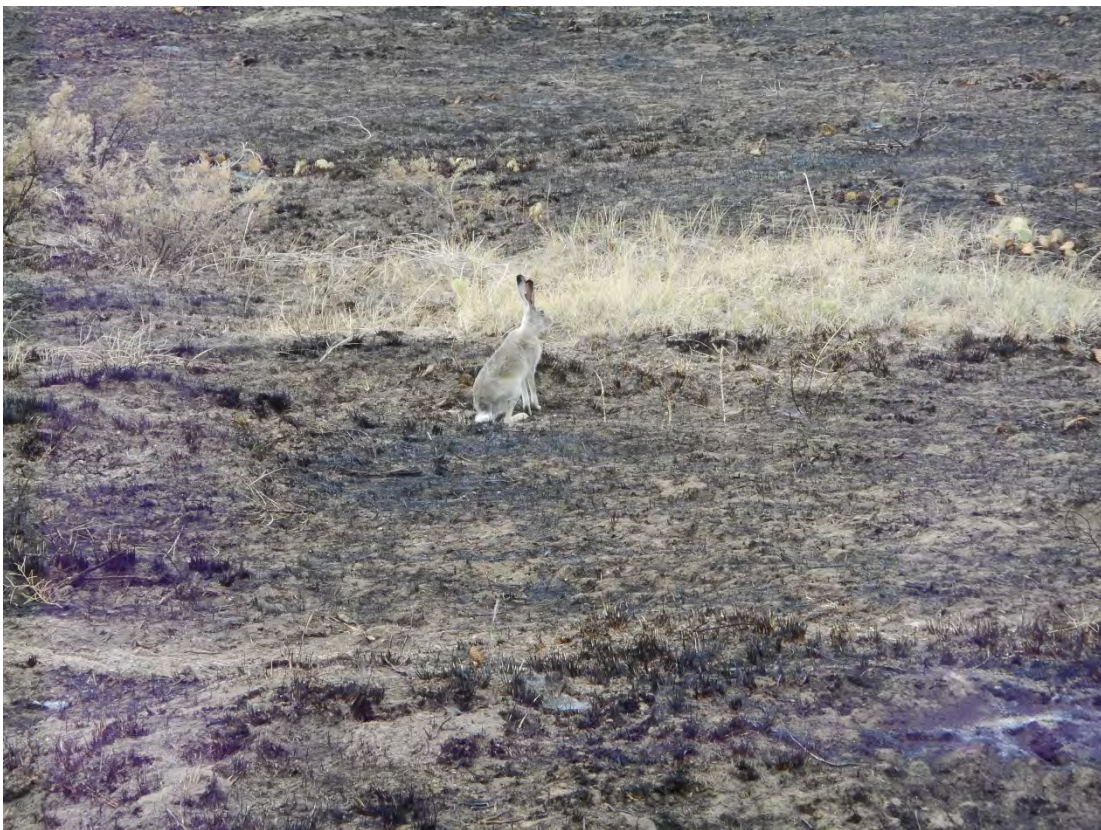
PL-6. Jackrabbit Observed on July 22, 2016

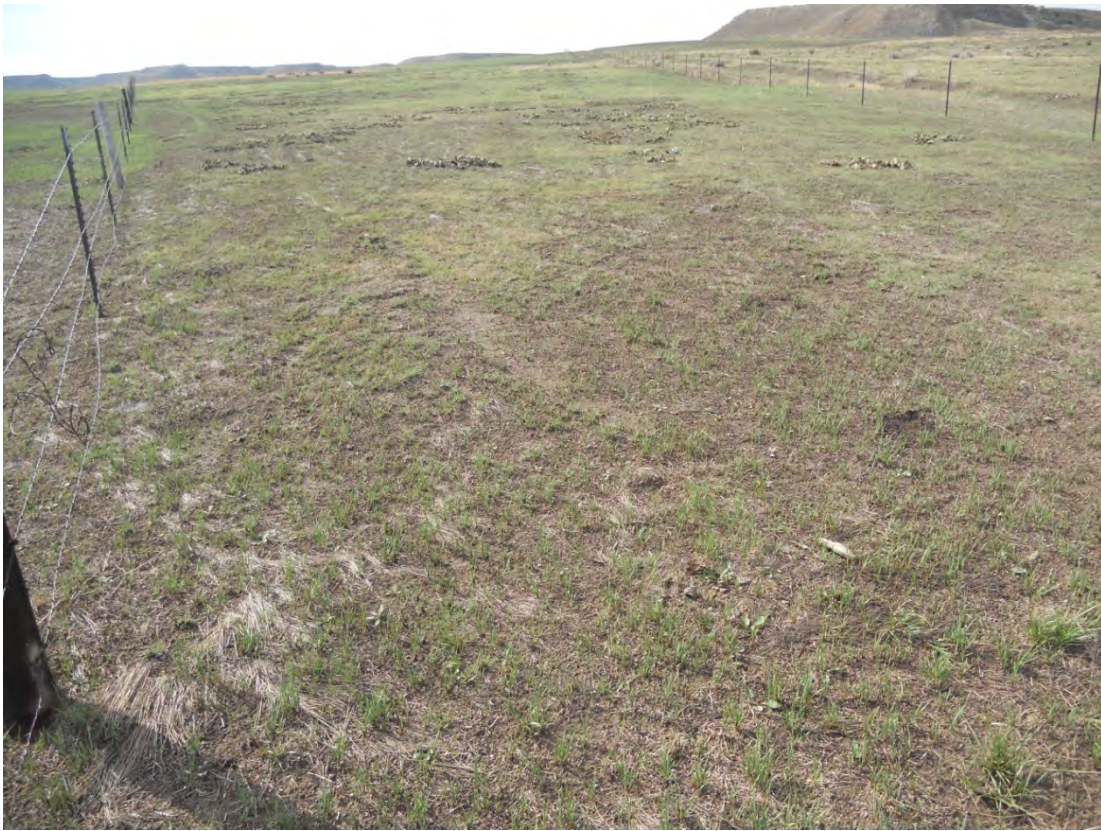
- **Edgemont, South Dakota:** A follow-up inspection was performed after a wildfire spread across the site five days after the annual inspection. Minor damage to a small section of the perimeter fence occurred during firefighting efforts and has been repaired. The fire did not impact the integrity of the disposal cell. DOE will study and monitor the effects of wildfires on the vegetative cover of the cell and the surrounding areas.

PL-7. Vegetation Regrowth Observed on September 6, 2016

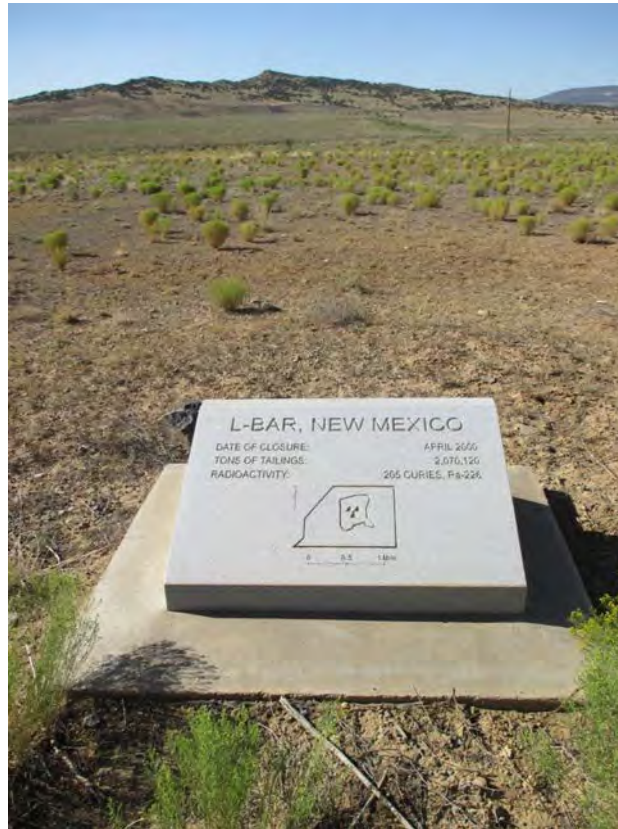
The site has one granite site marker, which is located north of the disposal cell adjacent to the site access road (PL-5). No maintenance needs were identified.

PL-5. Site Marker

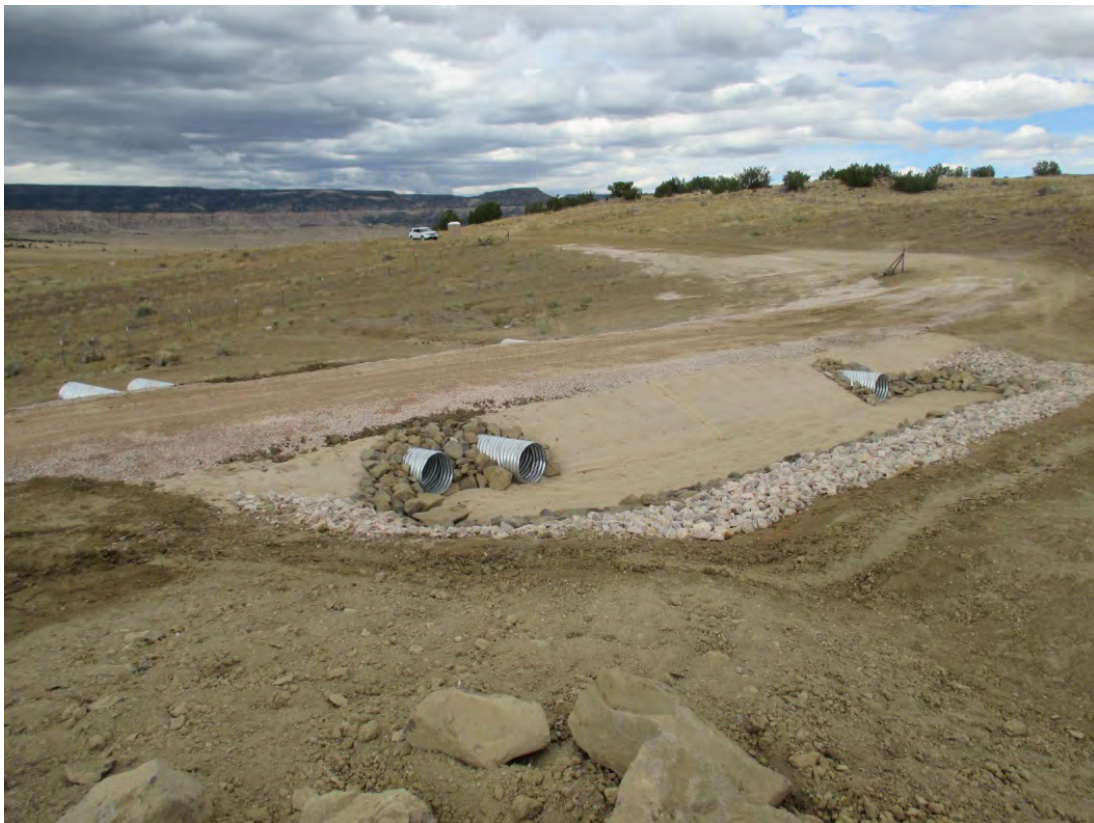
- **L-Bar, New Mexico:** Culvert installation was completed at a site access road to prevent further damage from an erosional gully. The section of fence along the east site access road was re-aligned to address impacts from erosion.
- **Sherwood, Washington:** An erosion feature is present at the toe of the tailings dam, and a forest fire on August 2016 impacted portions of the site. A follow-up inspection is planned for late 2016.
- **Shirley Basin South, Wyoming:** Concentrations of radium-226 and radium-228 continued to exceed their respective alternate concentration limits at three wells. NRC concluded that there is no current risk to human health and the environment. Groundwater monitoring will continue in accordance with the LTSP.

PL-12. New Culvert Across East Site Access Road
